Smoke and Dye Testing Summary

High Level Sewershed

Test ID	Test Type	Date Inspected	Company / Super.	Blower MH	Ground Condition	Notification Made?	Total Length
S1028-145	Smoke	11/18/2008	ADS/TM	S09QQ1031MH	Dry	Yes	1,111.81

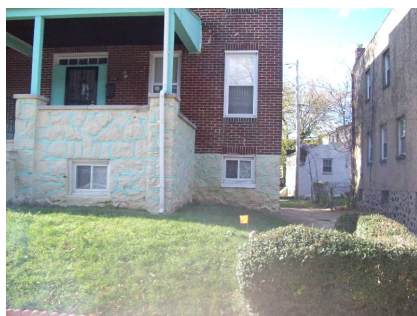
Picture \S1028-145-OB01-P01.jpg

Comments Smoke from cleanout in front yard. 5116 Queensberry Ave.

Comments Front of house, 5116 Queensberry Ave.

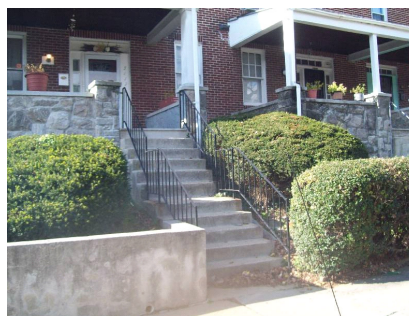
Picture \S1028-145-OB02-P01.jpg

Comments Smoke from service lateral in front yard. 5112 Queensberry Ave.

Comments Front of house, 5112 Queensberry Ave.

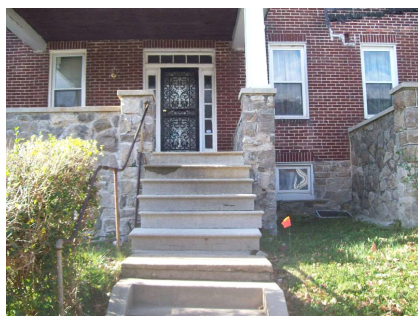
Picture \S1028-145-OB03-P01.jpg

Comments Smoke from cleanout in front yard. 5104 Queensberry Ave.

Comments Front of house, 5104 Queensberry Ave.

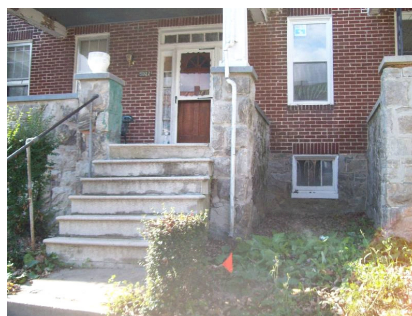
Picture \S1028-145-OB04-P01.jpg

Comments Smoke from cleanout in front yard. 5022 Queensberry Ave.

Comments Front of house, 5022 Queensberry Ave.

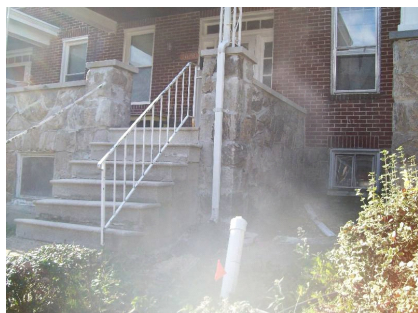
Picture \S1028-145-OB05-P01.jpg

Comments Smoke from cleanout in front yard. 5020 Queensberry Ave.

Comments Front of house, 5020 Queensberry Ave.

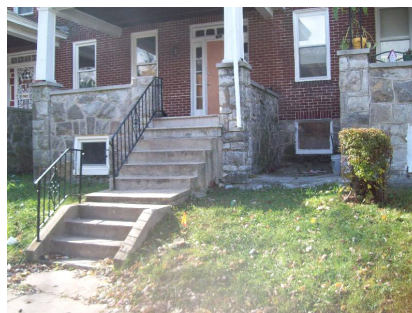
Picture \S1028-145-OB06-P01.jpg

Comments Smoke from cleanout in front yard. 5016 Queensberry Ave.

Comments Front of house, 5016 Queensberry Ave.

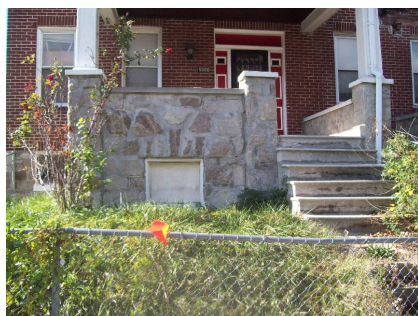
Picture \S1028-145-OB07-P01.jpg

Comments Smoke from cleanout in front yard. 5000 Queensberry Ave.

Comments Front of house, 5000 Queensberry Ave.
